### Minerals Inspection Report

Mine Name: Castle Peak	Permit Number: S/013/0011	Mine Status: Active
Operator Name: Lance-Conn LLC	Inspection Date: October 18, 2013	Permit Fees: Paid
Inspector(s): Paul Baker	Inspection Time: About 1:00 to 2:30 PM	Bond Amount: \$12,000
Attendee(s):	Weather: Mostly cloudy, 50s	Bond Escalation: 11/01/2014
Inspection Purpose: Routine inspection		Prior Inspection: None recorded

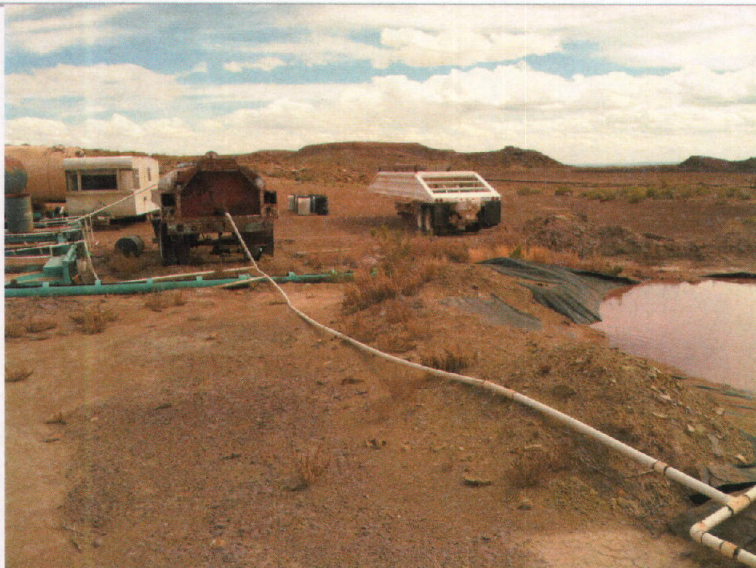
I visited the mill area; drill holes 4 and 5; and disturbances I, II, III, IV, and V in T. 8 S., R. 16 E., Section 36. The mill site had what appeared to be a small portable crusher, a small screen, a camper trailer (unlocked), two tanker trucks (probably for water), a belly dump trailer, two ponds, a large tank, and several barrels and buckets. The barrels and buckets appeared to be empty or to be partly filled with sand (ore?). The liner in one of the ponds appeared to be intact, but the liner in the other pond did not go to the edge of the pond.

Some of the facilities at the mill site.

There is some debris at the mill site that needs to be cleaned up. The operator should attempt to establish vegetation in disturbed areas that will no longer be used for mining. The ponds should not be used for processing until the liners are properly in place.

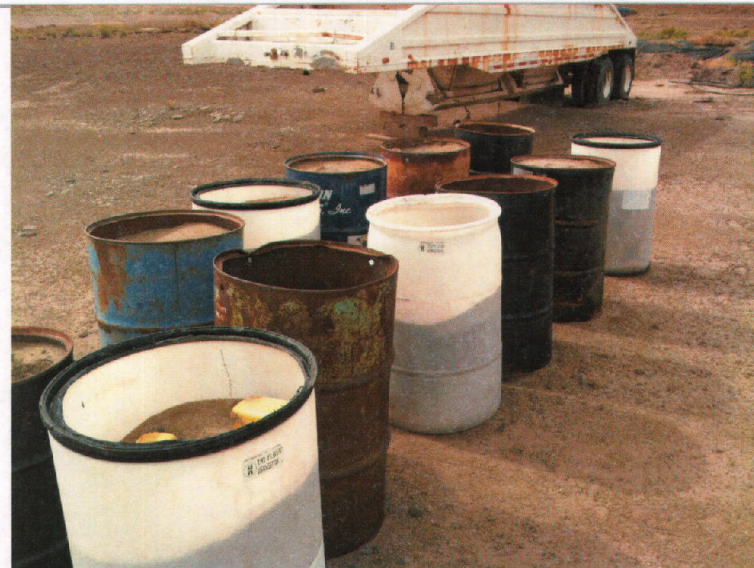
On February 24, 2012, the Division received a document with some details of the process planned for extracting minerals. The "intended leachates" include acetic acid, sodium carbonate and bicarbonate, ammonium hydroxide, sodium hydroxide, and sulfuric acid. I did not see containers labeled with these chemicals, but none of the containers were labeled.

Barrels partially filled with sand. The sand may be ore.

It is not clear what chemicals are in the ponds, barrels or tanks. Please update the plan to reflect what is actually at the site. The operator needs to determine whether a permit from the Division of Water Quality is required.

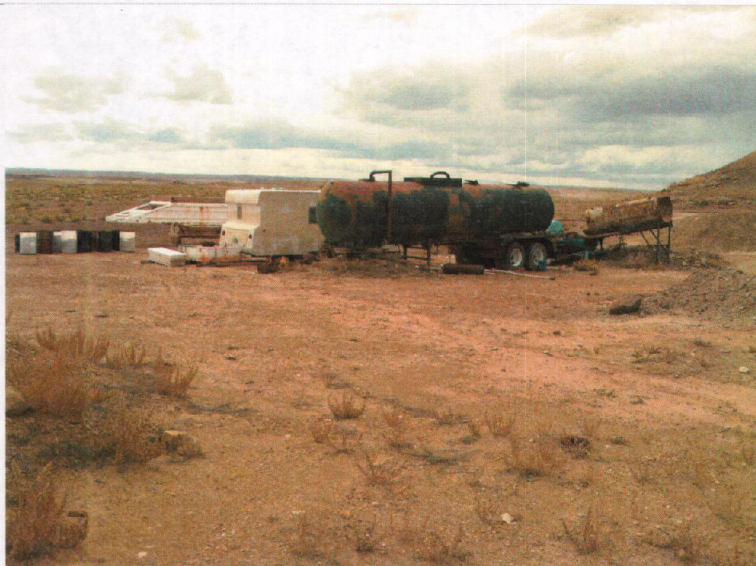
Another view of facilities at the mill site.

The reclamation surety bond needs to include equipment left on site. The surety is inadequate based on the equipment at the mill site. Either remove equipment not needed or submit additional bond. Reclamation surety is due for escalation on 11/01/2014.

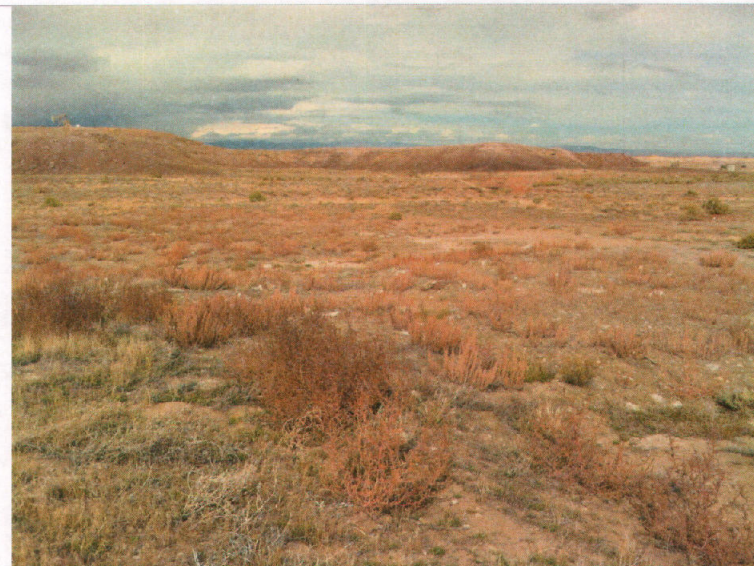
8. <i>Soils</i>	<input type="checkbox"/>	<input type="checkbox"/>
9. <i>Revegetation</i>	<input checked="" type="checkbox"/>	<input type="checkbox"/>
I believe I found the locations for disturbances I through V. The areas had been disturbed, but the topography in the disturbed areas was comparable to surrounding areas. There was some halogeton, Russian thistle, and cheatgrass in the disturbed area, but I do not believe there was any desirable vegetation.

Disturbance in Section 36 (see text).

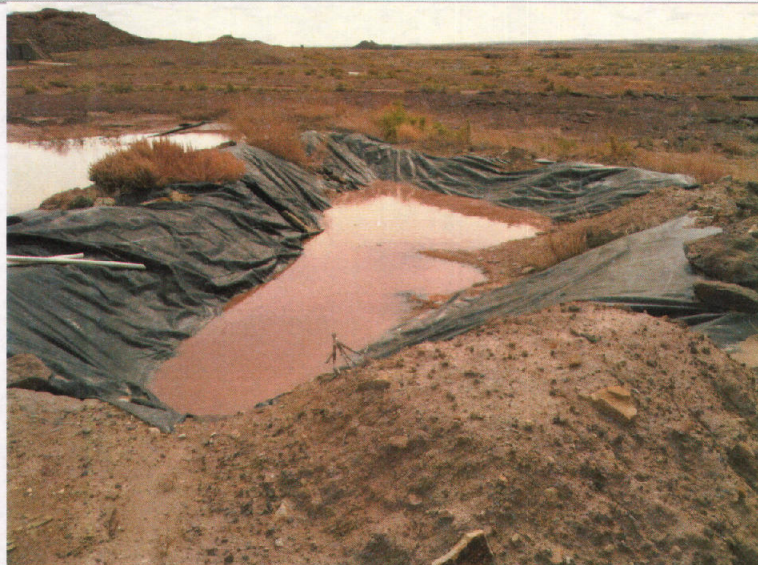
One of the two ponds.

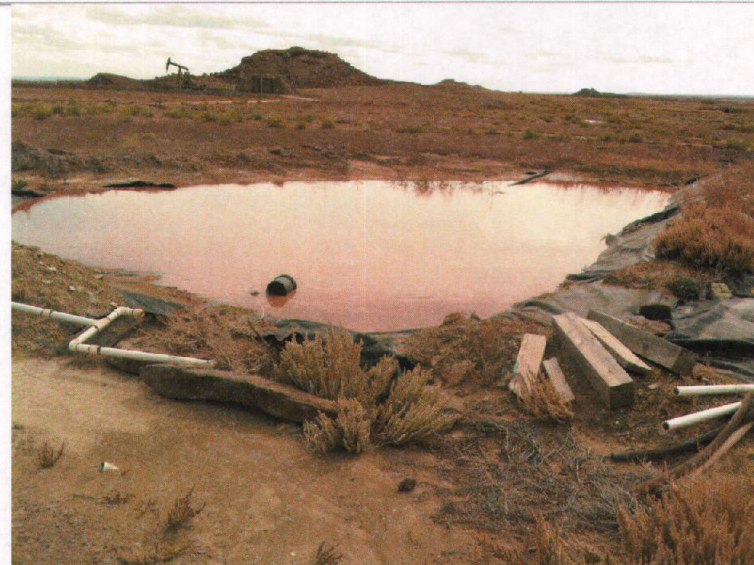
The second of two ponds. Note that the liner on the far side does not extend above the water level.

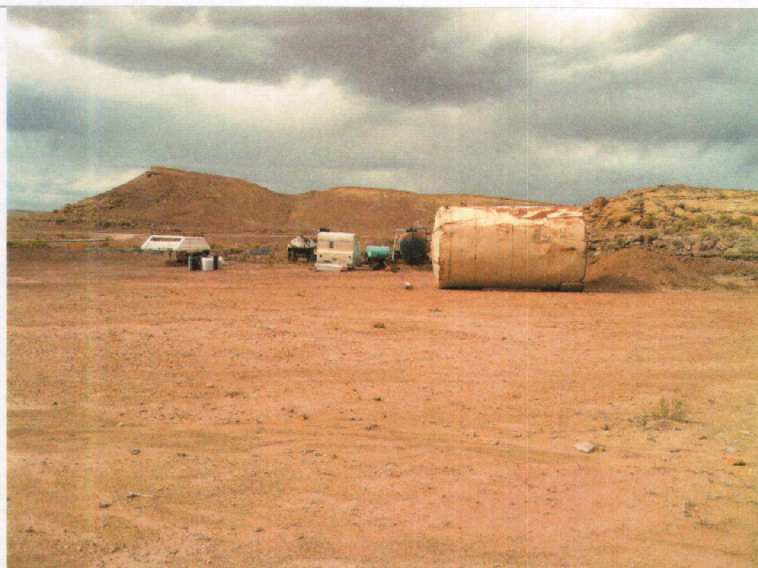
Another overview of the facilities.
